Leaking Underground Storage Tank Sites
Maximum Extent of Groundwater
Contamination Detected
(based on data collected by consultants
contracted by owners/operators/volunteers)
Holbrook, Arizona

Arizona Department of
Environmental Quality
December 2006

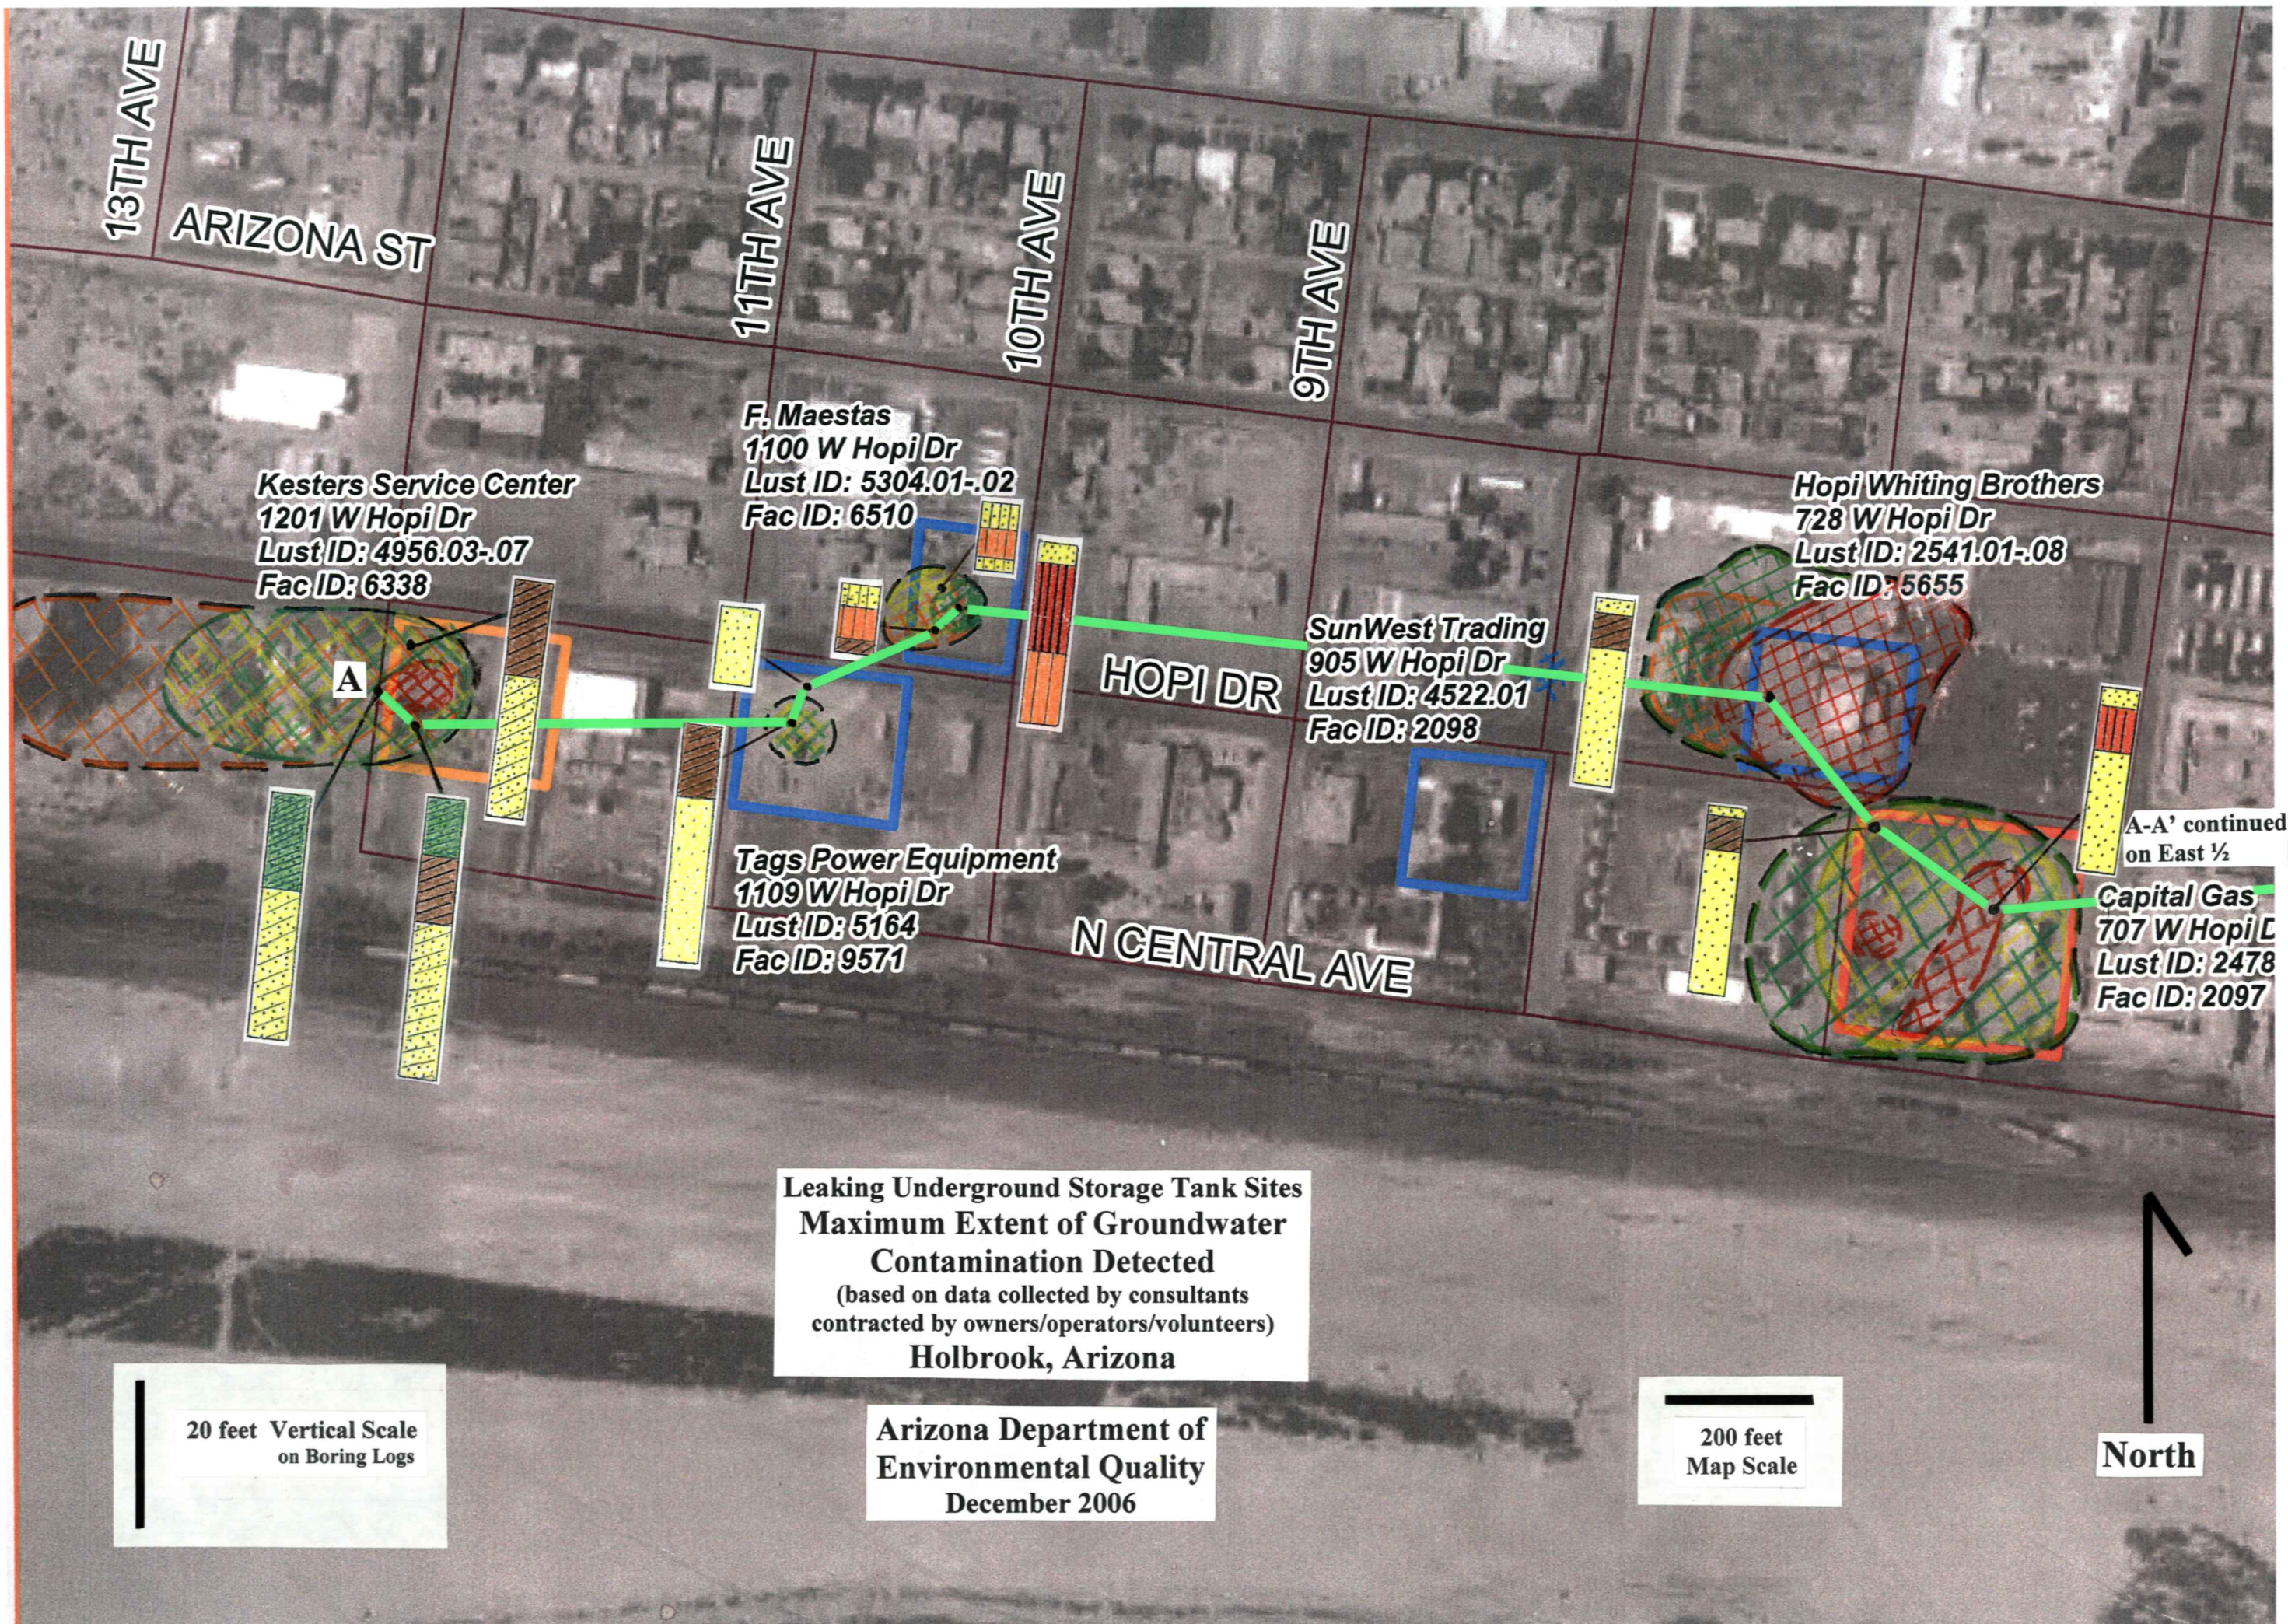
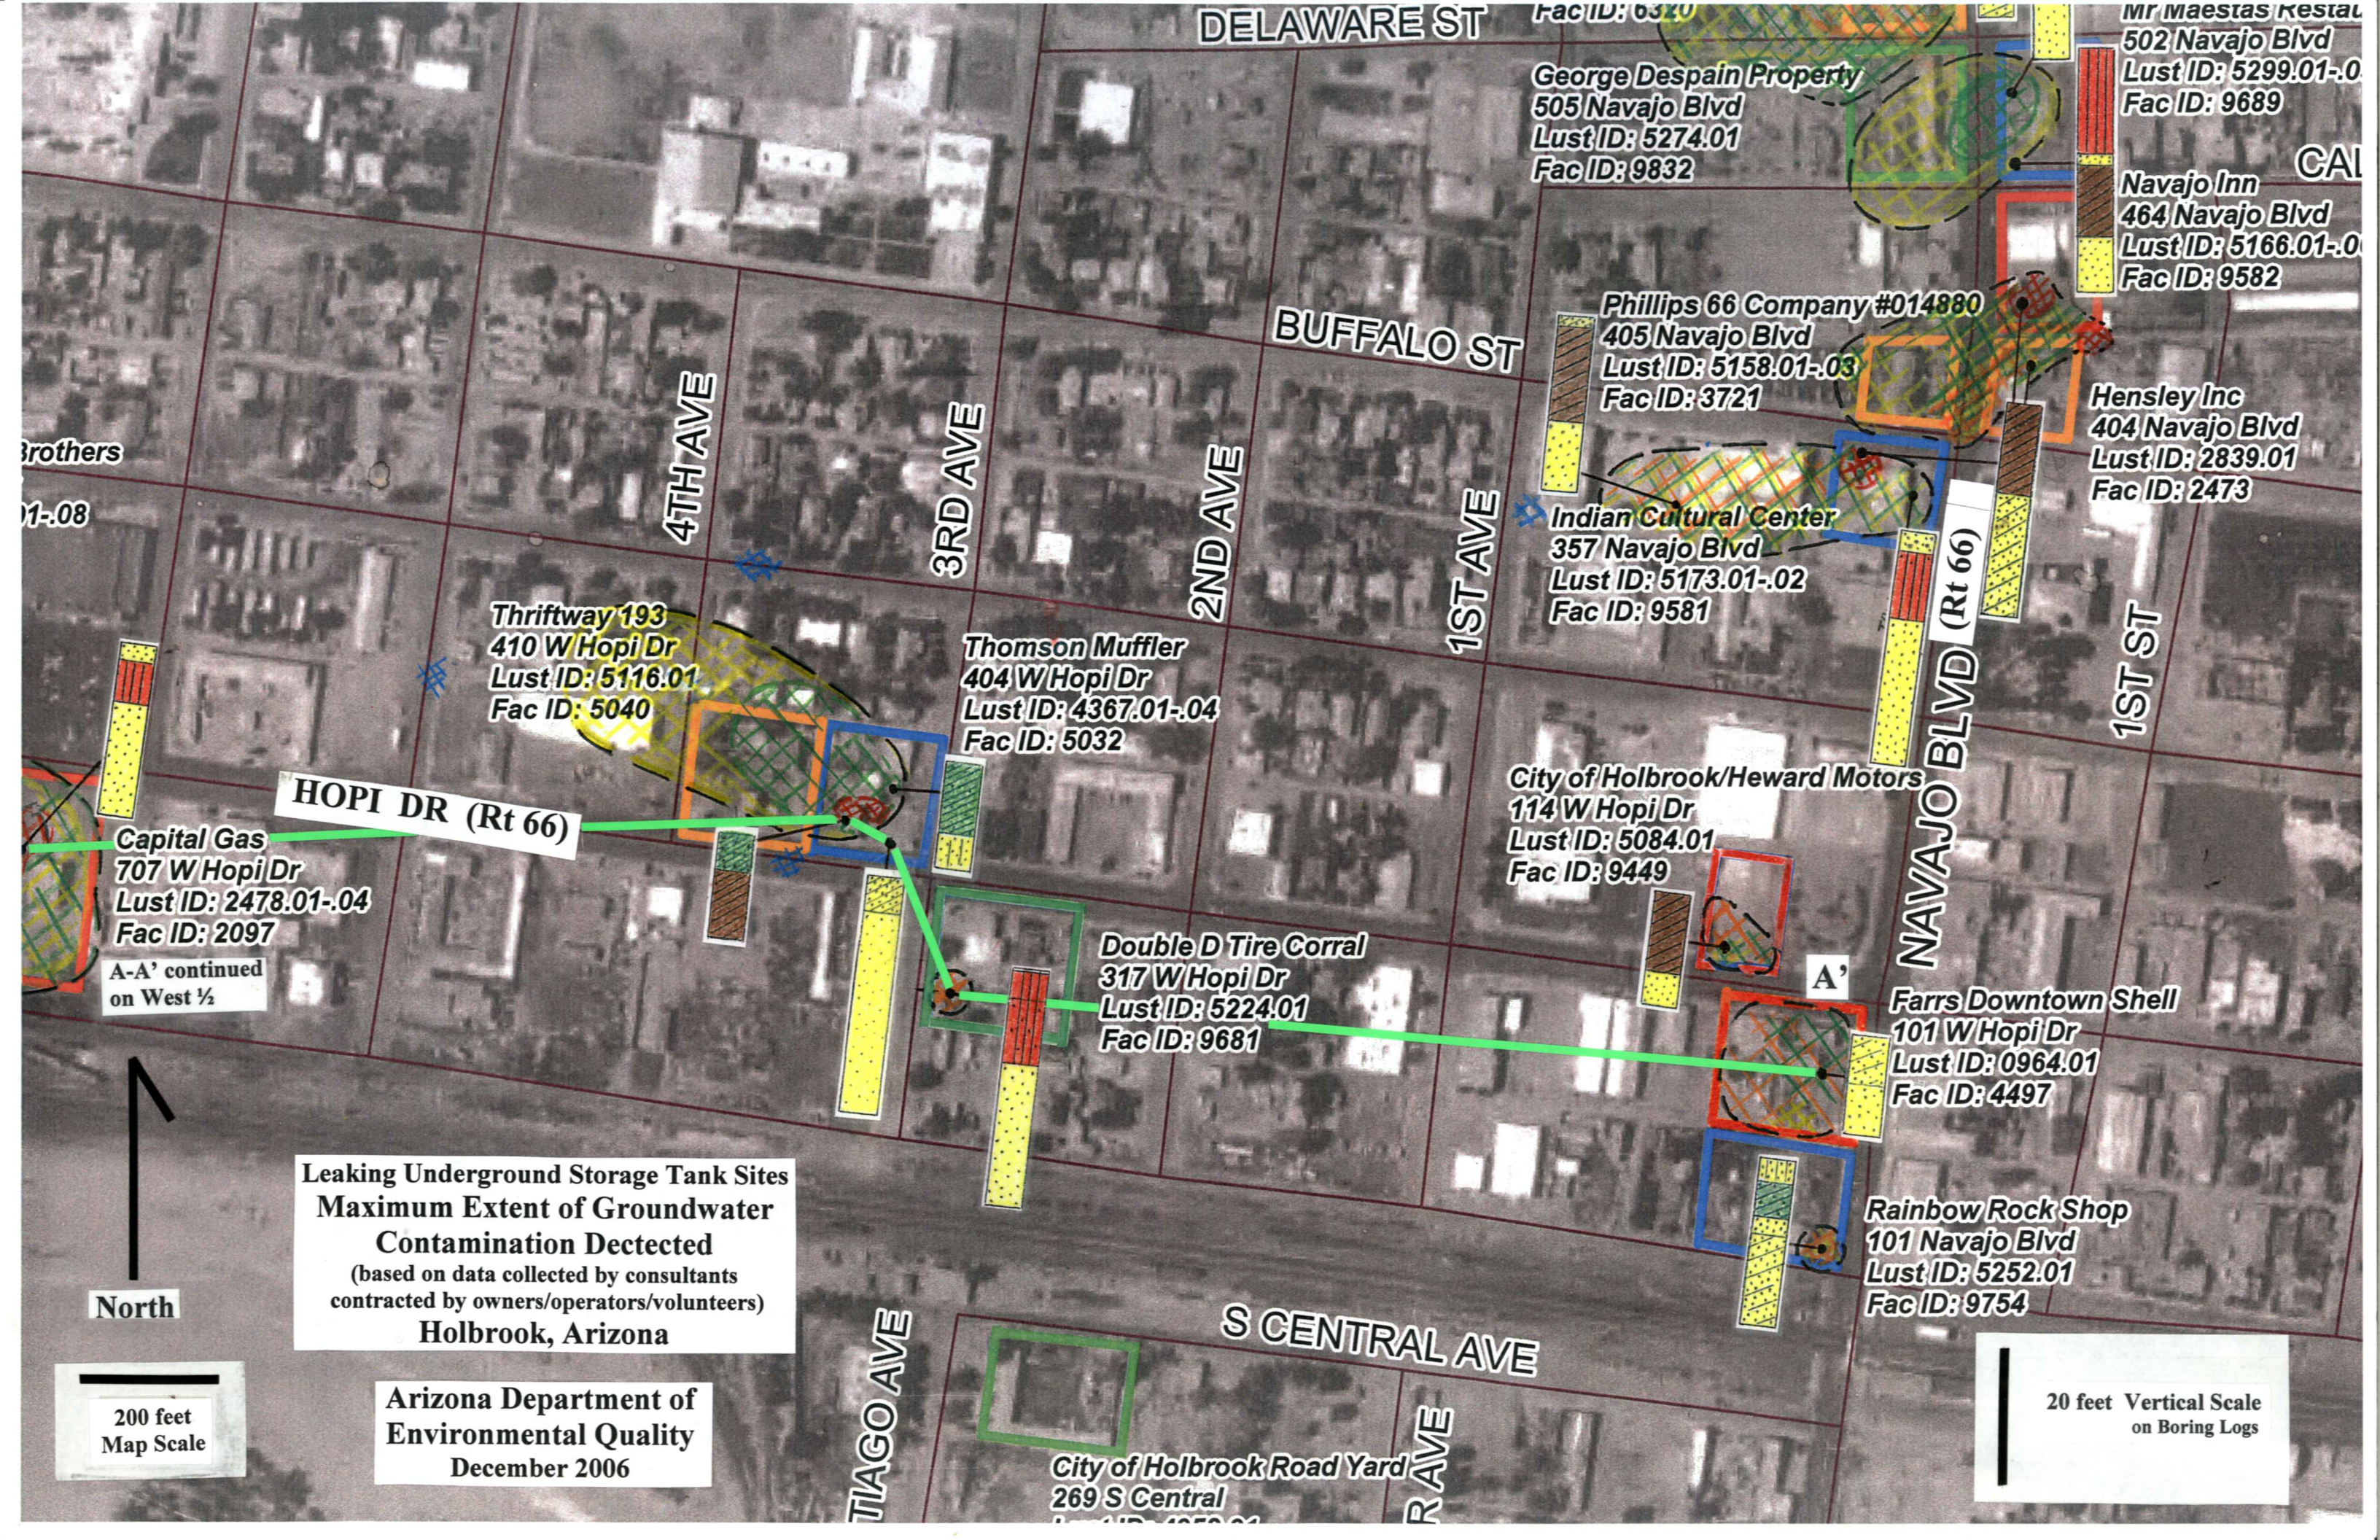
A-A' continued
on West 1/2

20 feet Vertical Scale
on Boring Logs
